# Appendix J

## Natura Impact Statement

**Straitéis Iompair na Gaillimhe**  
**Galway Transport Strategy**

**GALWAY TRANSPORT STRATEGY  
NATURA IMPACT STATEMENT**

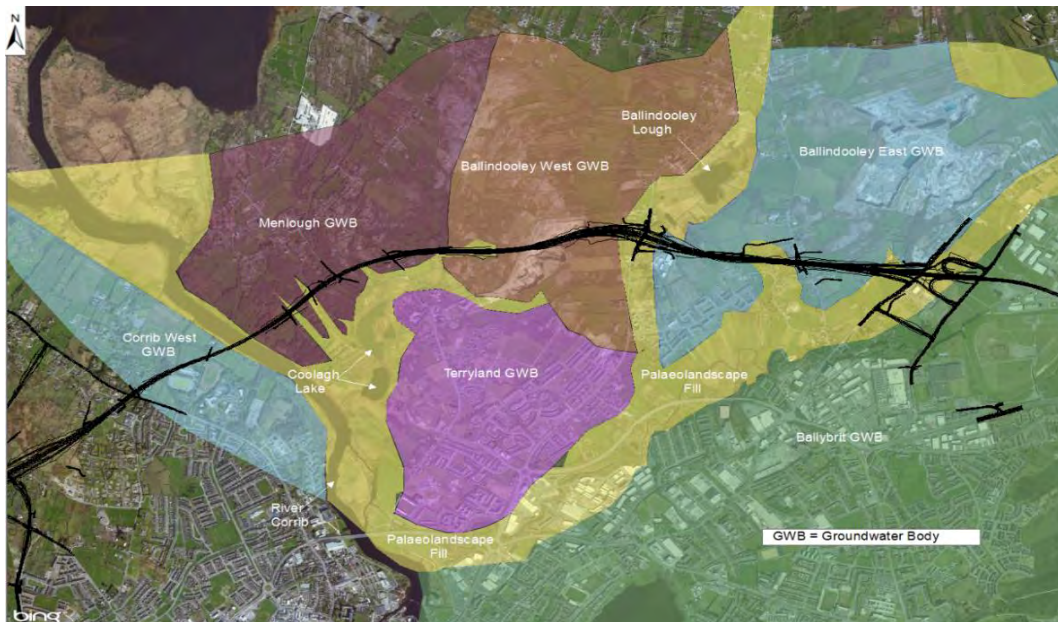
**Figure 3.2: Groundwater bodies in the Coolagh Lakes and Ballindoooley area**

These deep palaeolandscape features and their clay dominated fills separate the hydrogeology of the area into a number of limestone blocks that form groundwater bodies, refer to **Figure 3.2**. These features also alter the recharge characteristics with all effective rainfall on the limestone areas recharging to ground and all effective rainfall on valley fill running off to surface water.

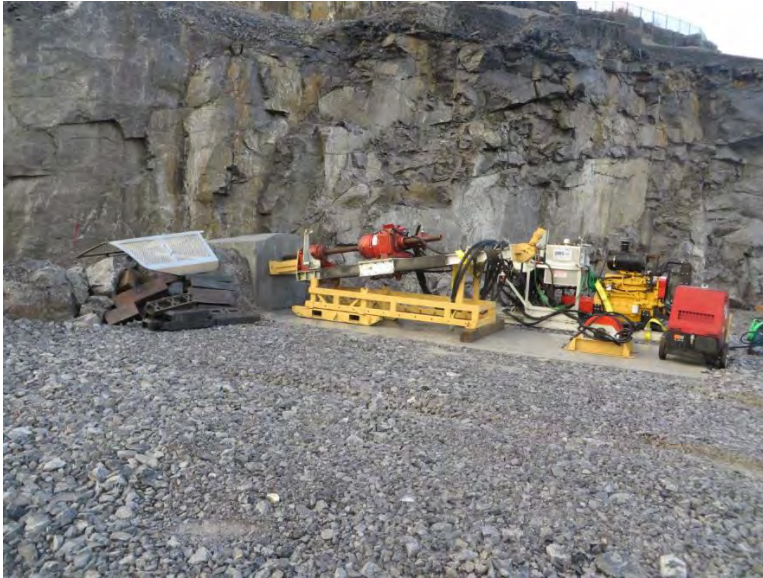
**Figure 3.6: BH01 Horizontal borehole at the eastern tunnel portal**

In total five boreholes (BH1, 3, 4, 5 and 6), were drilled both in Lackagh Quarry and in the adjacent fields west of the quarry (Refer to **Table 3.2** and **Figure 3.5**. One horizontal rotary core borehole (BH1) (**Figure 3.6**), was drilled at an inclination of  $\sim 12^\circ$  off horizontal, through the western quarry face, at the location of the proposed eastern tunnel portal and four vertical rotary core boreholes were drilled in the fields adjacent to the quarry on the west, above the proposed tunnel alignment.

The stratigraphy of Section 1 and 2 was investigated by a 280m horizontal borehole (BH01) drilled sub-horizontally along at a 12° off horizontal incline along the alignment of the proposed road development beginning at the eastern tunnel portal location. The ground conditions in Section 2 were also determined using vertical boreholes BH04 and BH05 which reached depths of 35m and 40m, respectively. The bedrock is described as strong to very strong, thickly bedded, pale grey, fine to medium grained slightly fossiliferous limestone. Argillaceous limestones found in the quarry face were not found during investigation of Section 2, suggesting that these beds are not present moving west. A thin 20cm band of laminated mudstone was encountered in BH04, however it is unknown whether this is a continuous layer or a cavity infill. BH04 and BH05 encountered several cavities, some not filled, and some infilled with clay.

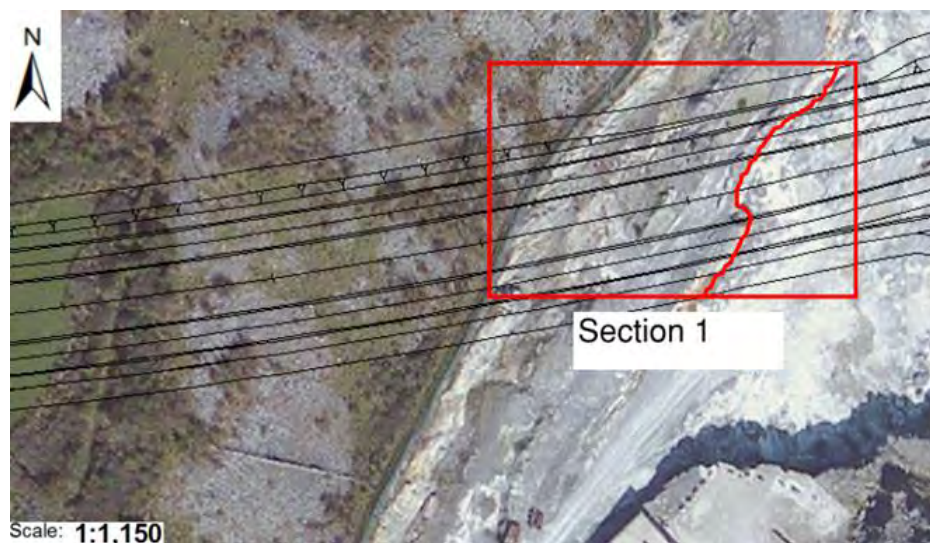
**Figure 3.7: Section 1 showing Lackagh Quarry and tunnel portal**

The proposed eastern tunnel entry portal is located within the now inactive Lackagh Quarry, on the western quarry wall. The western quarry wall comprises of a lower and upper bench. The lower bench floor level is at +15mOD which rises steeply to +24mOD at the upper bench with a slope angle ranging from 75 degrees to sub-vertical in places with an uneven surface, (**Figure 3.7**). The distance between the top of the lower bench to the base of the upper bench ranges in width from 28m to 40m around the proposed tunnel portal area, (**Figure 3.8**). The upper bench ranges in height from 18m to 20m with a slope angle ranging from 70 degrees to sub-vertical. The maximum elevation of the quarry wall in this location is +44mOD.

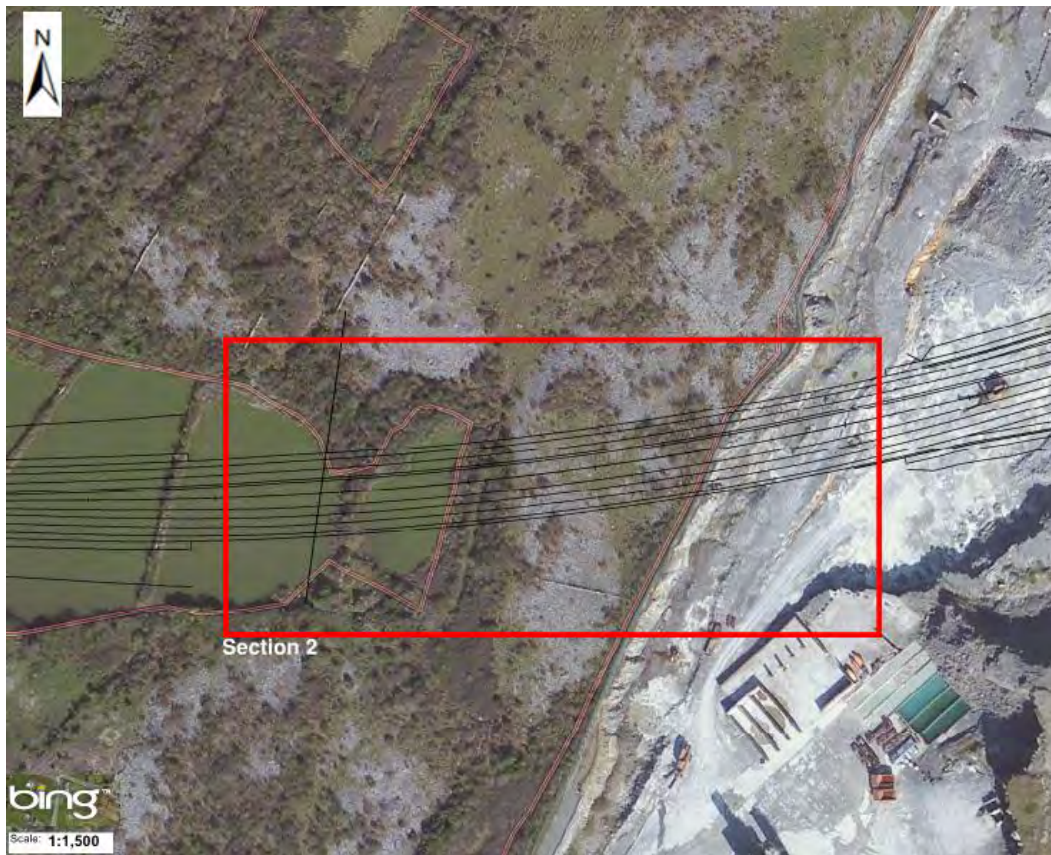
**Figure 3.11: Section 2 showing Lackagh Tunnel footprint**

Section 2 focuses on Lackagh Tunnel which overlaps with Sections 1 as the tunnel extends into Lackagh Quarry, **Figure 3.11**. The proposed tunnel lies beneath the Limestone pavement within the Lough Corrib cSAC and agricultural fields. The ground levels of the exposed Limestone pavement, **Figure 3.12**, range from 36.4 to +40.5mOD along the proposed alignment, falling from east to west. The tunnel extends west beyond the Limestone pavement boundary approximately 110m, overlain by agricultural land where the ground level reduces to +30.7mOD in the west from +36.4mOD in the east.

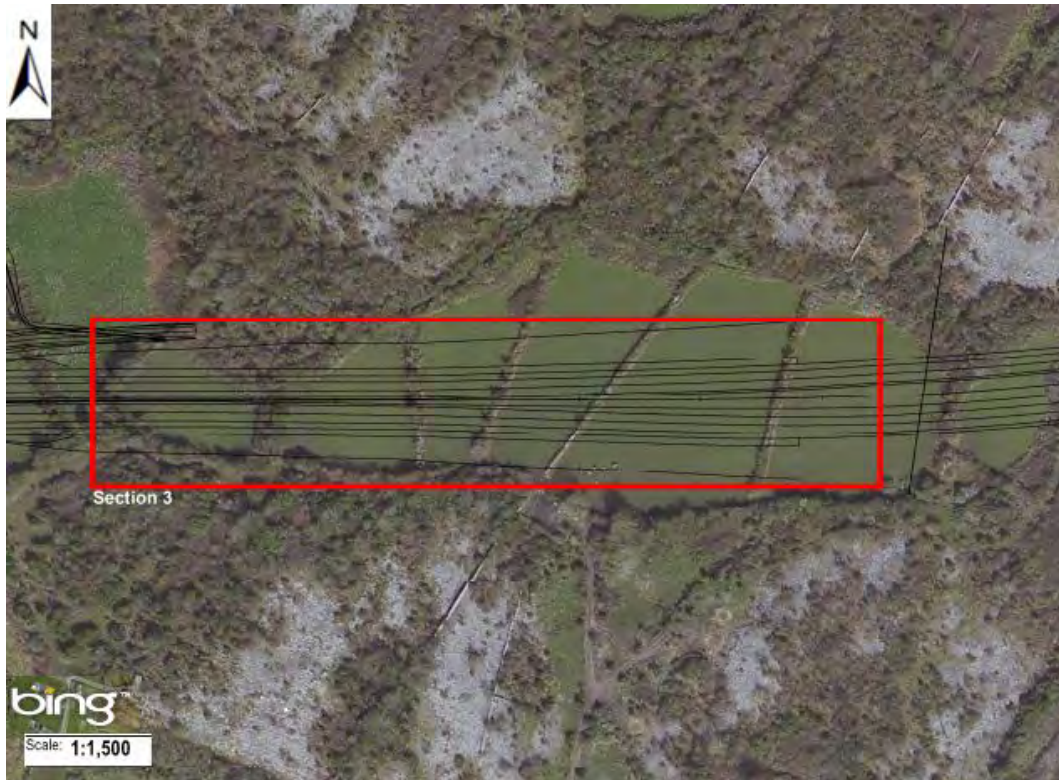
**Figure 3.13:** Section 3 footprint

Section 3 is bounded on the north and south by Limestone pavement. The proposed road development is located in an area made up of agricultural fields and stone boundary walls, **Figure 3.13**. The existing ground levels fall from east to west from +30.7 to +13.41mOD.

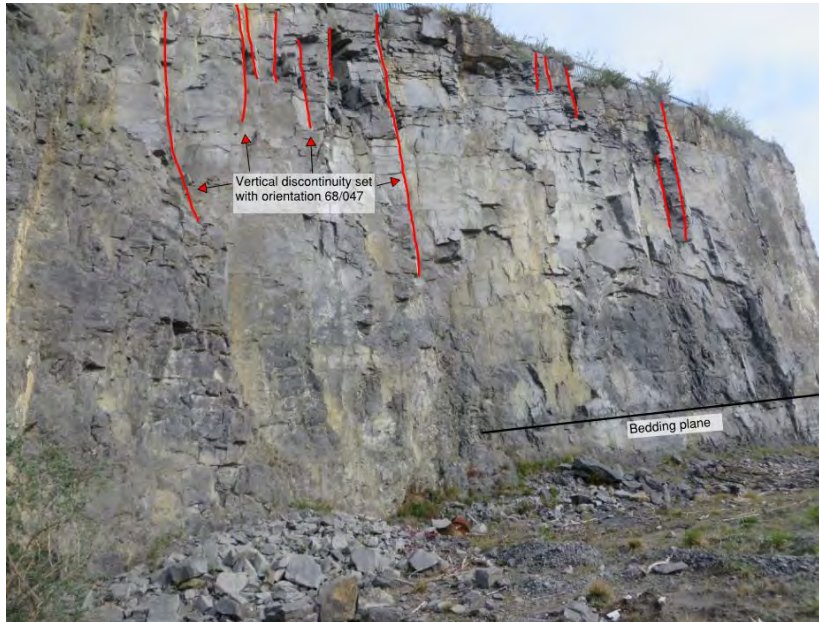
**Figure 3.16: Exposed discontinuities on the upper bench**

The vertical and horizontal discontinuities are visible on the exposed quarry face and are more evident in the upper bench wall, as the lower bench wall has been heavily affected by blast induced fractures.

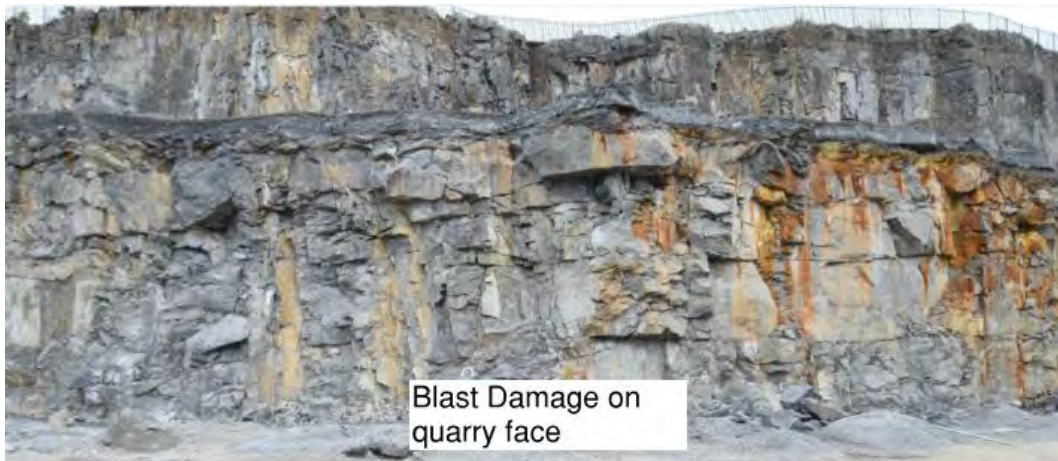
**Figure 3.17: Blast damage on quarry face**

The western face has been left unprotected since the closure of the quarry in 2010 and has gradually deteriorated over time. Previous quarry workings have resulted in a heavily fractured rock face, both natural and blast induced (**Figure 3.17**), and unsafe overhangs and loose rock are present in the area of the proposed tunnel portal.

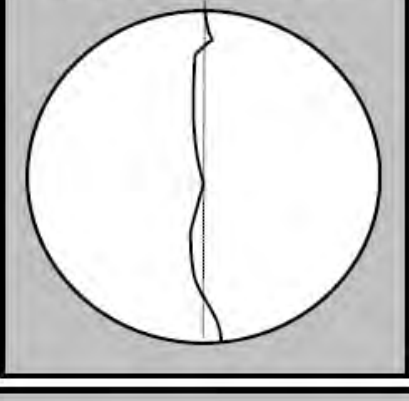
| TENSILE STRENGTH | MPa | 12.60 | | |
| BOREHOLE | | BH01 | | <b>SAMPLE FAILURE SHAPE</b><br> |
| DEPTH | | 180.24-180.50 | | |

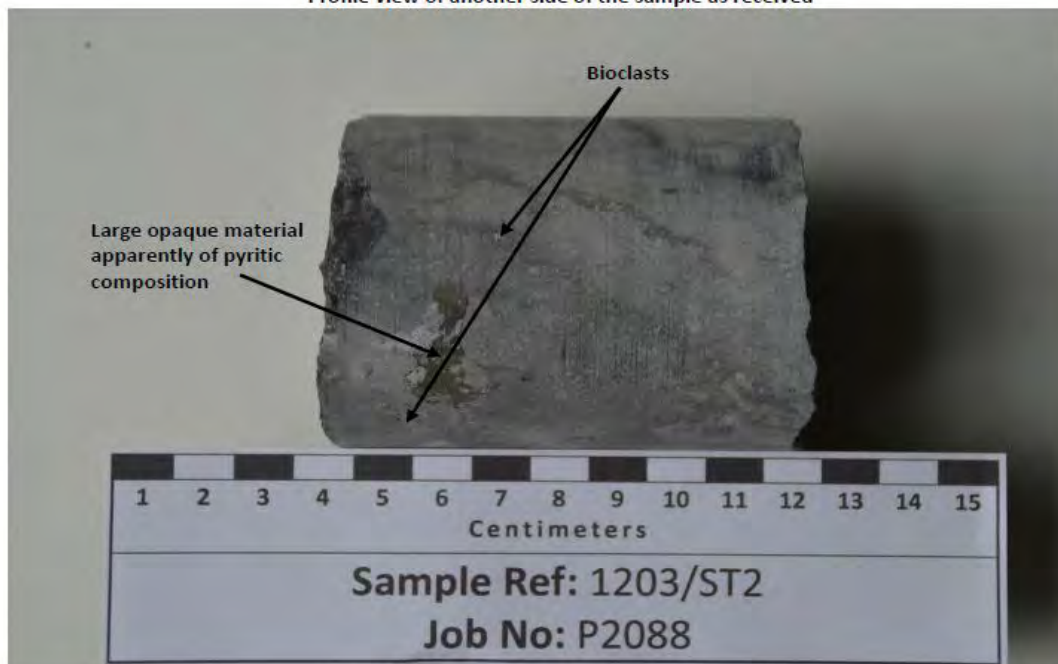
Profile view of another side of the sample as received

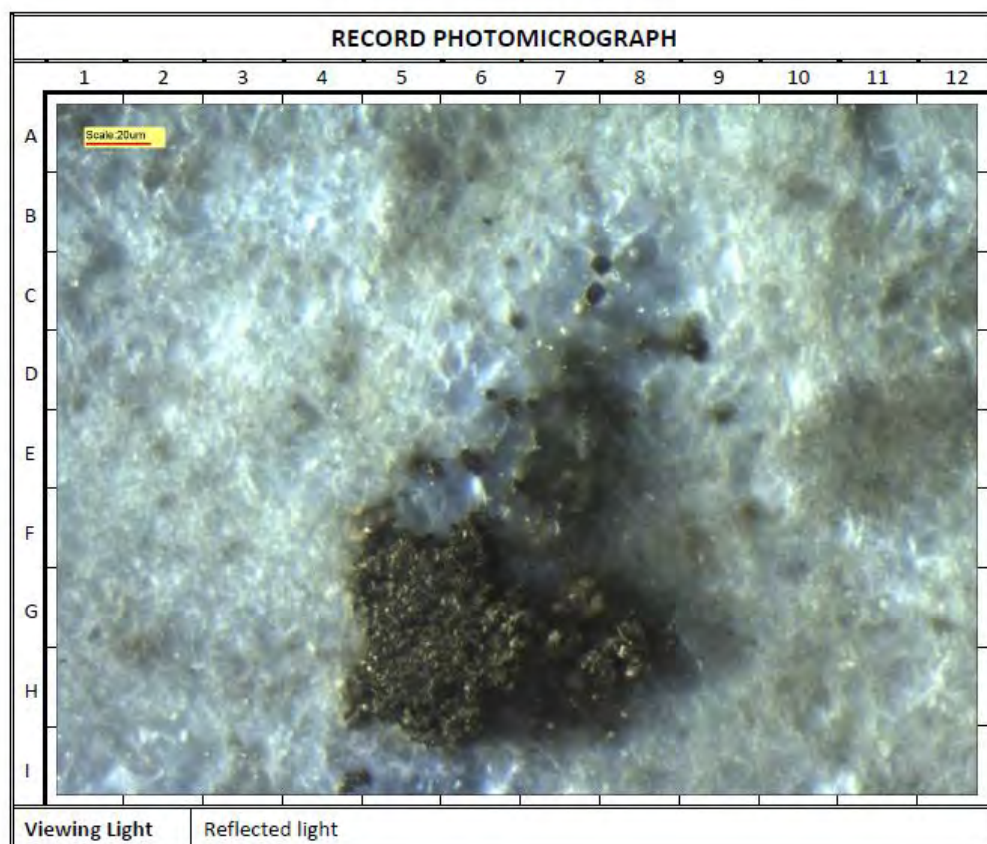
Closer view of the section through the sample, showing framboidal pyritic grains (brass colour: C7 and G5).
